### ABOUT ADSP-21369 SILICON ANOMALIES

These anomalies represent the currently known differences between revisions of the SHARC® ADSP-21369 product(s) and the functionality specified in the ADSP-21369 data sheet(s) and the Hardware Reference book(s).

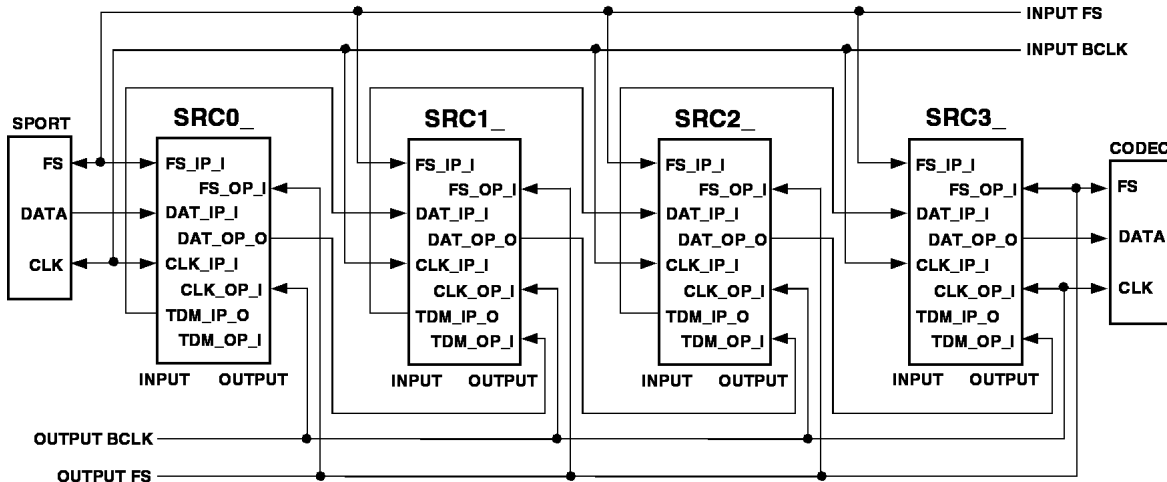
**10. 0800020 - Input Shift Register Anomaly in ASRCs (Asynchronous Sample Rate Converters) impacts Daisy-Chained TDM mode:**

In the TDM Daisy chain mode the ASRCs can be connected as follows to achieve TDM mode:

When the ASRCs are used in TDM Daisy chain mode, the MSB of the input data is lost at the output of each ASRC in the chain. This anomaly is applicable for the TDM mode in both the bypass and non-bypass modes. The following example provides the expected failure pattern for the bypass mode, since in bypass mode the incoming data is not modified by the ASRC.

For a TDM daisy chain with 8 channels in BYPASS mode, the output of the final ASRC in the chain will result in three-bit left shift for the channels 1 and 2, two bit left shift for the channels 3 and 4 and one bit left shift for the channels 5 and 6. The channels 7 and 8 will not have any data shift. At the output end, three MSBs will be lost for the channels 1 and 2, two MSBs will be lost for the channels 3 and 4 and one MSB will be lost for the channels 5 and 6.

The workaround for this anomaly must be carried out in software only on the device providing input data to the ASRCs in TDM daisy chain mode. It can not be implemented on the output data from the ASRCs. The workaround implementation in software adds some core MIPS to the application. For devices like ADCs/CODECs, the workaround may not be implemented directly. For such systems, two serial ports of the SHARC should be dedicated for this purpose. One serial port should be used for receiving the data from the ADC/CODEC and the other one should be used for transmitting the modified input data to the ASRC.

When the ASRCs are used in TDM daisy chain mode, only the 24-MSBs of the input 32-bit data is used and the 8-LSBs are not used by the ASRC. The anomaly can be worked around by shifting the 24-MSBs of the data to the 8-LSBs as follows:

1. Right shift the input data for channels 1 and 2 by three bits. Now the 24-MSBs which has the data are placed in the bits from 28 - 5.
2. Right shift the input data for channels 3 and 4 by two bits. Now the 24-MSBs which has the data are placed in the bits from 29 - 6.
3. Right shift the input data for channels 5 and 6 by one bit. Now the 24-MSBs which has the data are placed in the bits from 30 - 7.
4. The input data for channels 7 and 8 need not be modified.

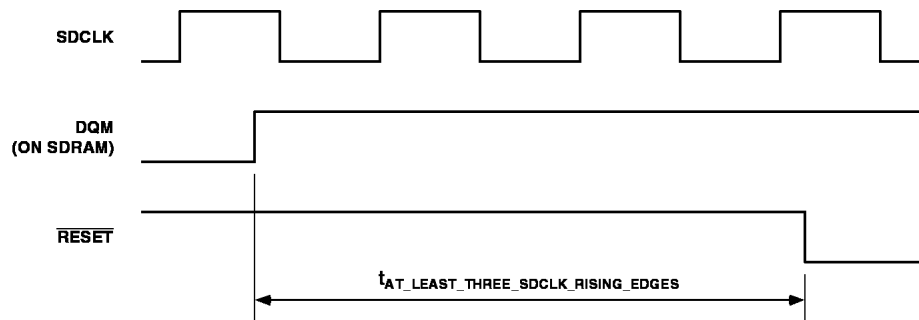
If the SHARC processor is in the process of fetching data from external SDRAM memory, initiating a Hard (hot) reset during this process may cause the SDRAM device to continue to drive the data bus during the entire duration of /RESET being asserted, and also failing to relinquish the external data bus even when the DSP comes out of /RESET.

If the DSP had been configured to boot via parallel external FLASH or EPROM (which shares part of the same data bus with the external SDRAM), the resulting bus contention on the external data bus between the DSP trying to boot from the FLASH memory and the SDRAM continuing to drive the data bus causes incorrect boot data to be loaded in, and the booting operation fails. Once the above state is hit, subsequent DSP Resets will not correct the situation. A power-cycling sequence is required to recover from this state.

Providing an external delay of at least 3 SDCLK clock cycles between the SDRAM's DQM signal and the /RESET\_IN to the DSP will also cause the problem to be avoided (see attached Figure).
