Re: Keitley 238 restoration

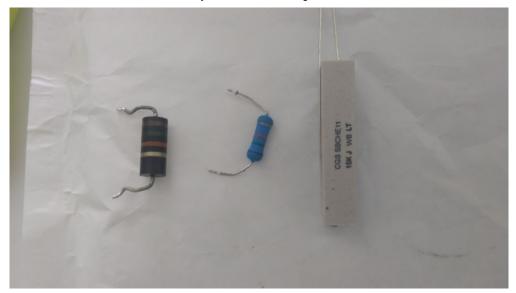
From left to right: the old one, the rejected replacement and Mr. Right (yes, size does matter).

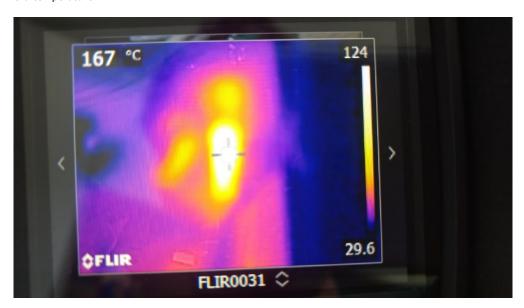
Old temperature:

The "new" resistor runs at 170°C. The old at 120°C. The new one is rated up to 235°C, so that actually makes sense but it's still way too high for my taste. Within operating limits or not, I won't have it. Ordered two of these:

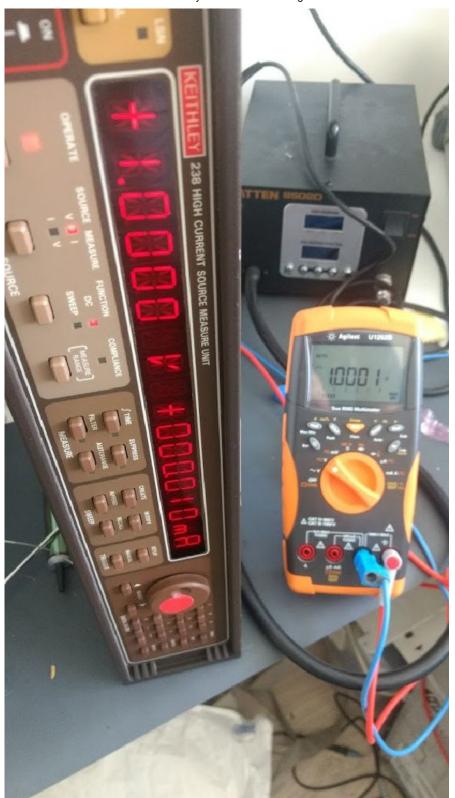
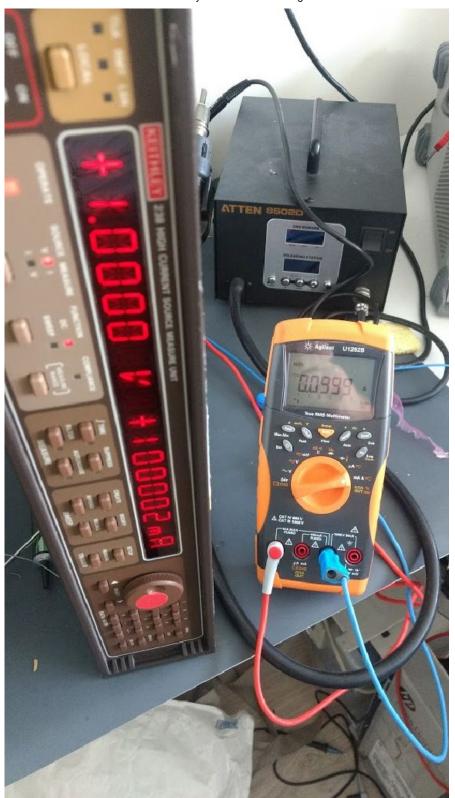
Accuracy is pretty good...

... but as can be seen in the picture, open loop current is off by about 10uA. Which seems like a lot. As calibration is supposed to be over the 488 interface and I have no gear for it, I'm going to close her up "as is". If anyone is interested in her, let me know!

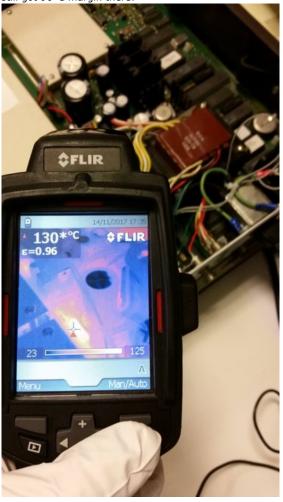
And the new resistors are running rather hot (130°C), as expected, but they're rated up to 220°C so still got 90°C margin there:

More worried about what it'll do to the PCB underneath since I did mount them down on the board, might go in again and lift them slightly off the board if I do open it up to install another fan. I'll also give the triax connectors a rubbing with methanol then.

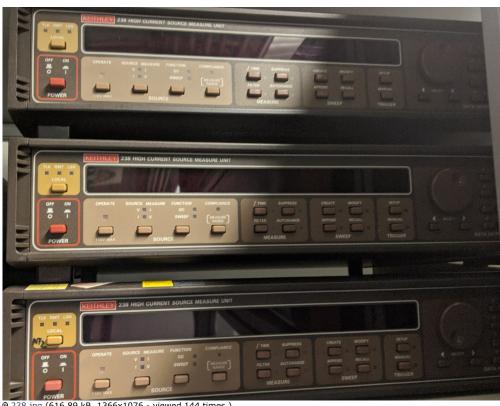
238.jpg (616.89 kB, 1366x1076 - viewed 144 times.)

i have three defect 238. 1. transformer going hot and smokes 2. no action 3. start, but not check.

in 1. the resistors between transformer was very hot, can by other defect more.

i think its not a problem from drawing power, more the transformer has eh short circuit. i will little open it and with acrylic lacquer and vacuum sealer press better inside. The 2. think can by the same problem.

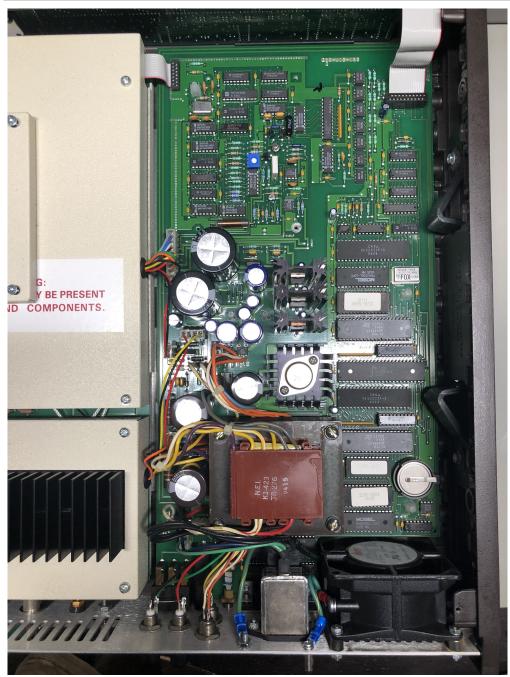
238_eprom_locations.jpg (2976.05 kB, 4032x3024 - viewed 111 times.)

Is it possible you uploaded the two different firmware files to the wrong eproms? 801 is near the fan, while 800 is closer to the middle of the board.
