Sencore LC-102 Cable 'zeroing' issue and 'fix'

Post subject: Sencore LC-102 Cable 'zeroing' issue and 'fix'

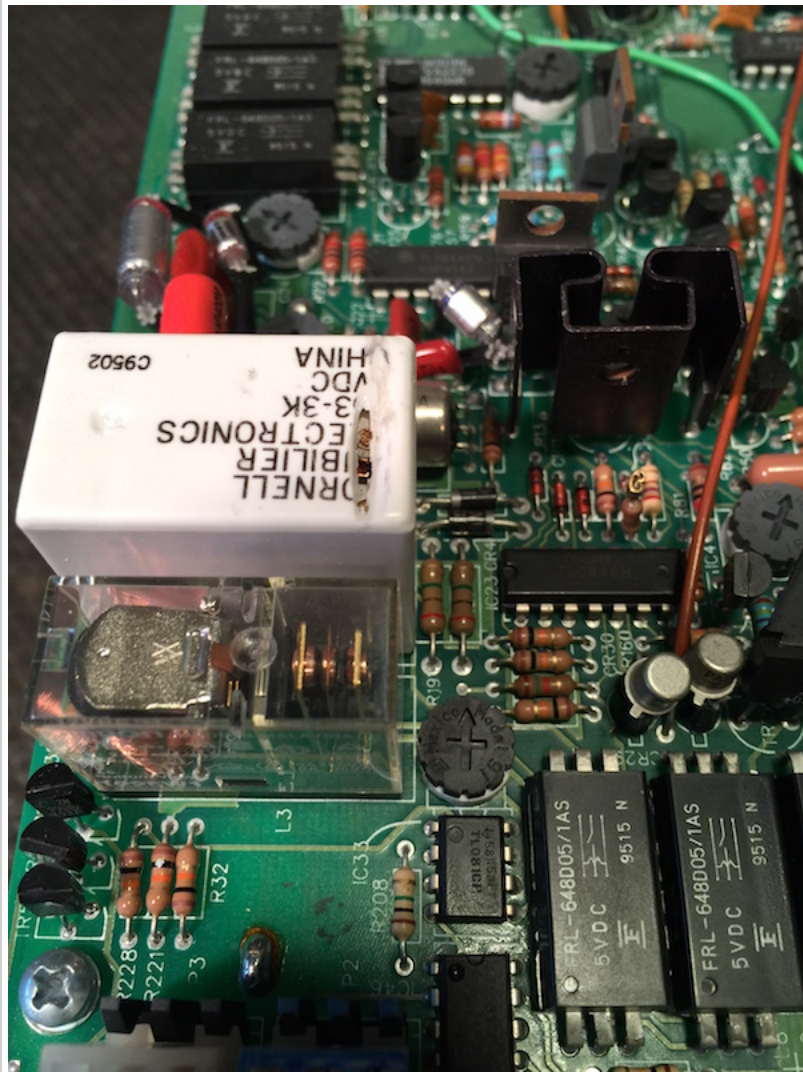
sencore2.jpg [230.88 KiB | Viewed 912 times]

So my 'hack fix' was to gain access to the relay contacts from the top. In the past I've successfully used a small drill to allow access, but since the guts are not visible I didn't want to take a guess where to drill. So I pulled out the Dremel and gently and very slowly sliced in to the top of the relay. I think the one advantage to this method is that the Dremel cut-off wheel melts more than cuts, which keeps dust and plastic flecks to a minimum.

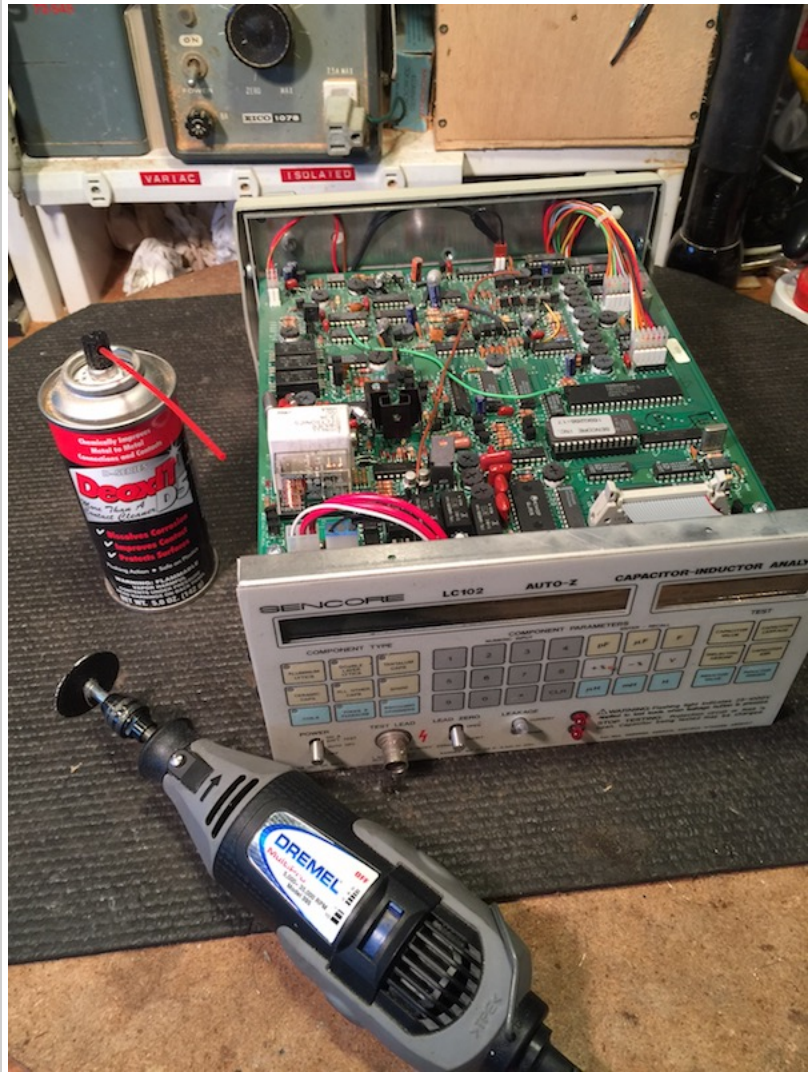
sencore3.jpg [191.95 KiB | Viewed 912 times]

The only tools needed. I gave the contacts a squirt of De-Oxit, cleaned things up and put a strip of tape over the opening.

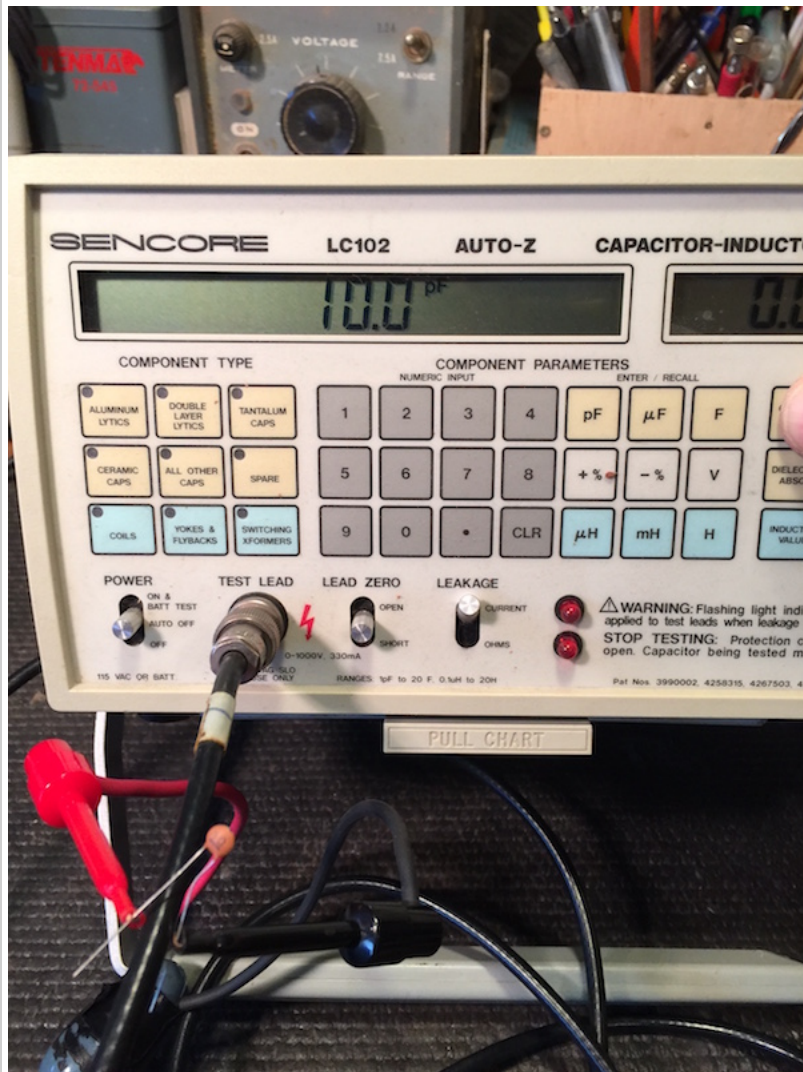
sencore5.jpg [205.33 KiB | Viewed 912 times]

Success! I was able to zero out the cable I had made several years ago with no issue. I did some testing and things seem to be accurate and working well. As a side note, I found that with the electronic zeroing feature, the LC102 is much less finicky about capacitance, cable type and length than reported. I grabbed a few other cable, RG-58, RG-59, RG-62 at various lengths and the Sencore zeroed fine - both open and short. And, the cable I made a long while back (and use today) measures 200pF...
