Tektronix AM503 Current Probe Amplifier: DC Level Fix

One of my Tektronix AM503 Hall Effect Current Probe Amplifiers (B075593, for future reference) lost its DC Level zero-ing capability:

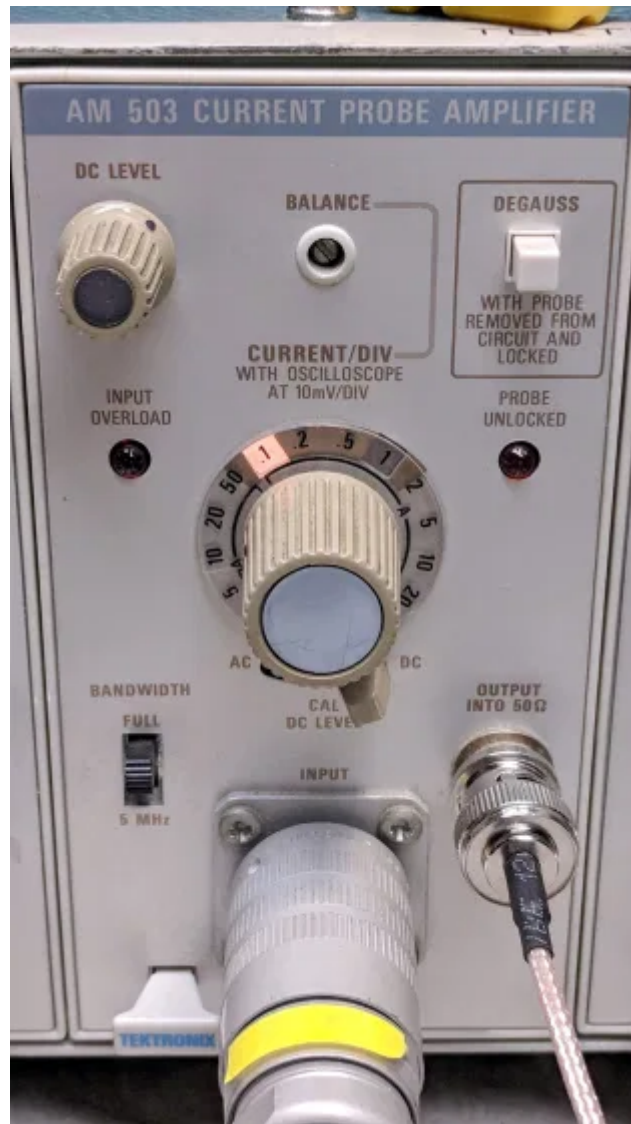
Tek AM503 front panel

The front-panel knob produced only positive output voltages from maybe 50 mV to the amp's upper limit around 200 mV (into a 50 Ω termination, Tek not being one to fool around with signal quality & bandwidth). Other than that, the amp seemed to work fine, but you definitely want a 0 V baseline

corresponding to no current through the Hall probe.

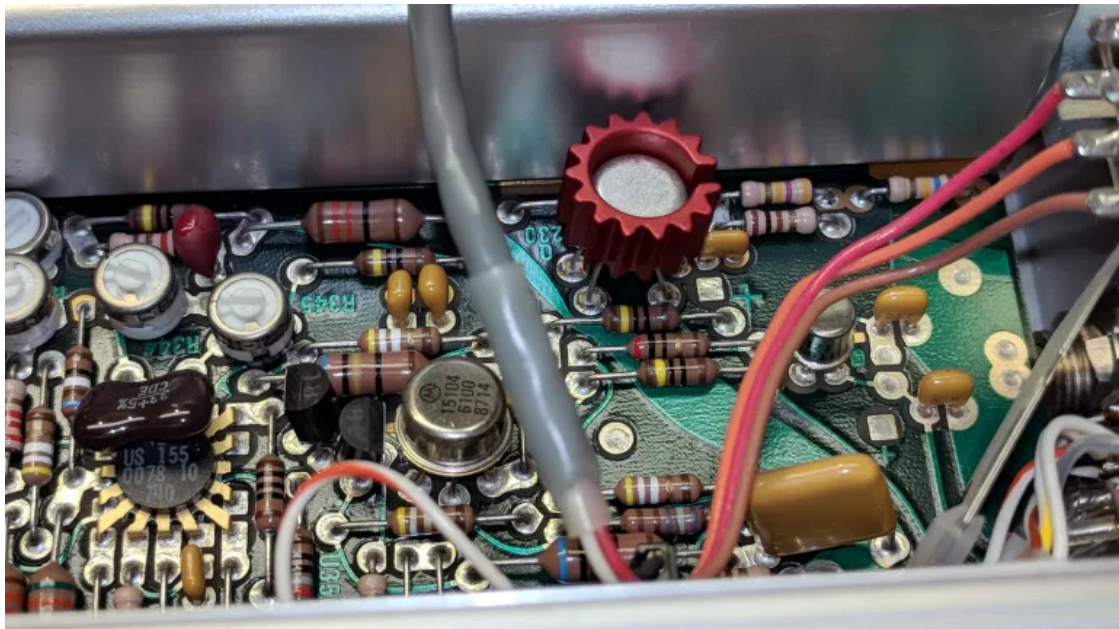
Tek AM503 – Q230 PCB detail

U350 is the round epoxy package in the the square spider-leg array over on the far left. Contrary to what you (well, I) might think, the index mark denotes pin 16, *not* pin 1:

Q230 is clad in the natty red heatsink in the PCB picture above. CR226 is the metal TO-18-ish can partially hidden by the orange-red-brown ribbon cable from the DC Level pot.

For future reference, C234 and C244 aren't installed in this PCB; they'd fit in the conspicuously vacant spots to the right and in front of Q230.

What may not be obvious at a first glance: Q230's pins sit in teeny individual *sockets* installed in the PCB. One might remove and reinstall Q230, should one be so inclined and, given that it's the first active device after the input attenuator, one might imagine such an action being necessary after a catastrophic *oopsie*.

- Turned the power off
- Waited for the supply voltages to drop
- Pulled Q230 slightly upward
- Wiggled-and-jiggled it around
- Shoved it back down
- Turned the power on

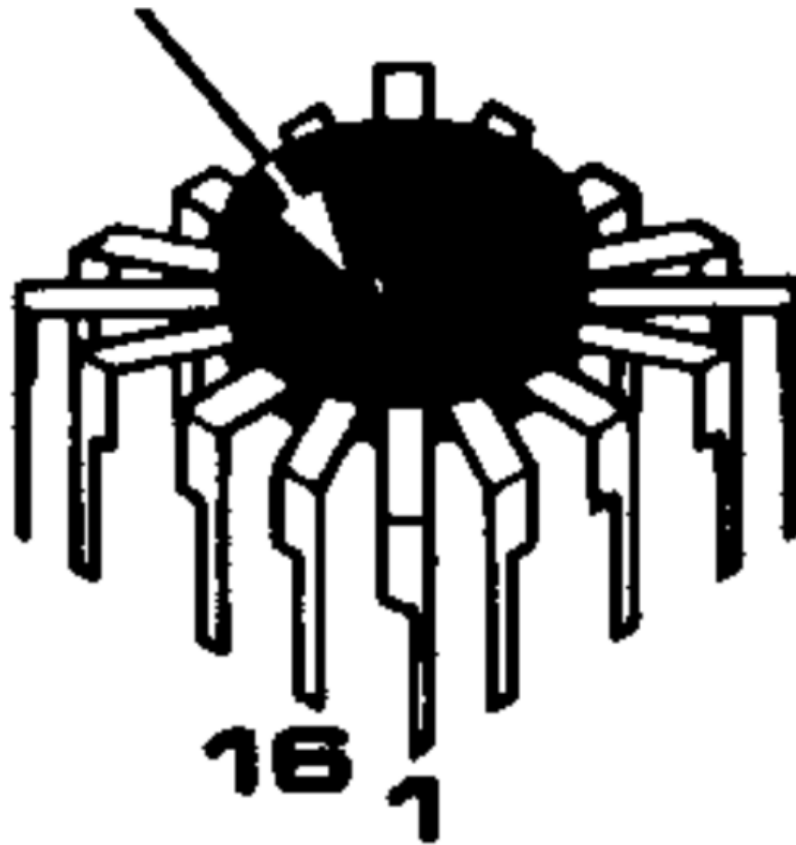
Tek AM503 Amplifier – Tek-unique IC pinout reference

INDEX

Which puts pin 1 at the upper right corner of the package on the PCB. The part listing in the manual says MICROCKT, LINEAR:VERTICAL AMPLIFIER / SELECTED, which makes perfect sense given Tek's oscilloscope business; if you needed a high-speed differential amplifier, that's what Tek's internal catalog would surely suggest. Newer AM503 revisions use somewhat less unobtainable op amps, although they replace the DC Level knob with one of those newfangled microcontroller thingies for some sweet auto-leveling action.

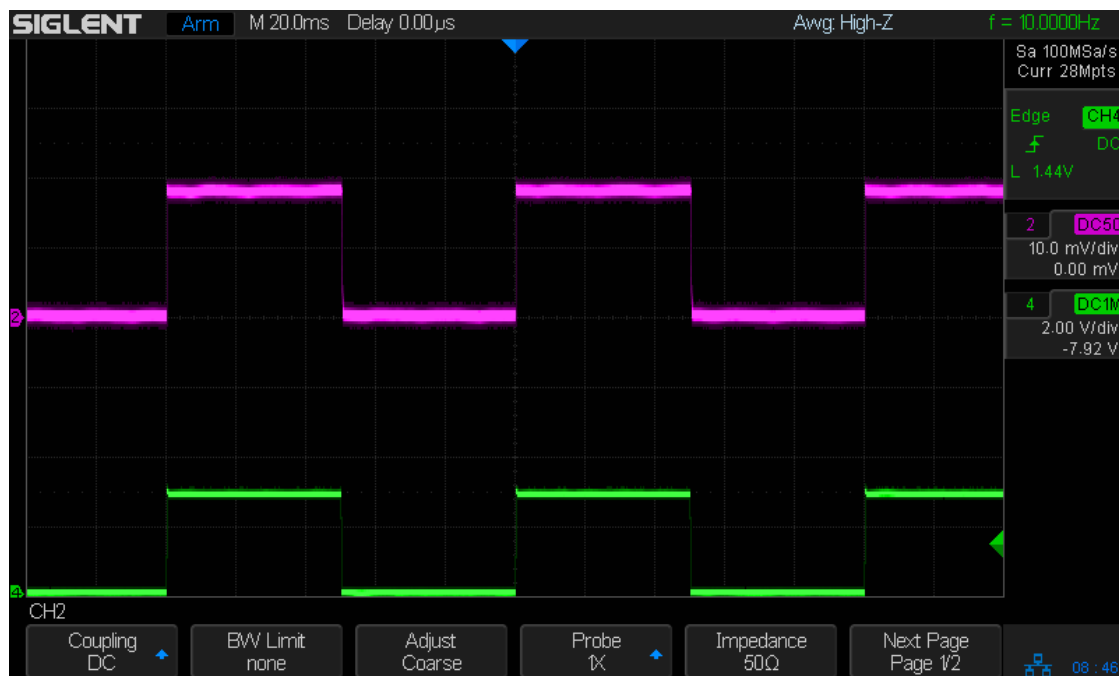
Tek AM503 – Q230 reseated

The output now has the usual ± 200 mV range centered at 0 V. The waveform shows a 100 mA signal at 50 mA/div, produced by a bench supply into a 100 Ω power resistor switched by a DC-DC SSR (<https://softsolder.com/2018/07/19/tek-a6302-current-probe-offset-resistor-tweakage/>).
