Re: Keitley 238 restoration

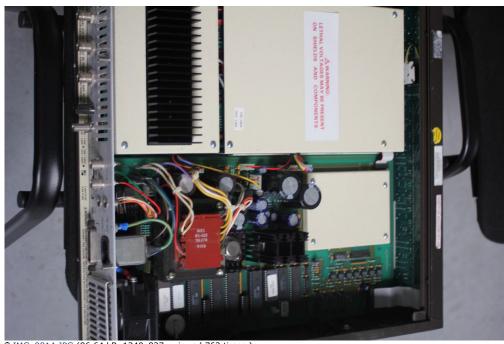
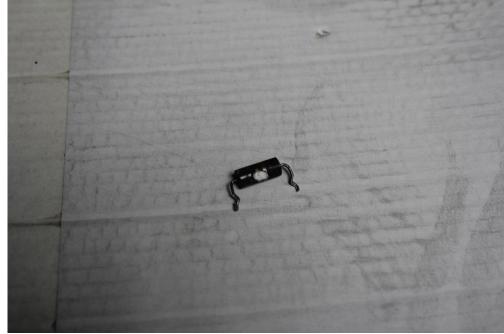
MG_9914.JPG (96.64 kB, 1240x827 - viewed 762 times.)

Oh noes. What now? Well, what I should have done from the start. Check that zener. Which acts like a 3-ohm resistor. That might be in its job description somewhere, but it seems to miss a few other points. Farnell again!

And voila. Functional now. Checks out against my Keysight 1252B. Haven't checked the entire range quite yet (need to install a new fan first) but there it is: restored Keithley 238. Ready to serve once

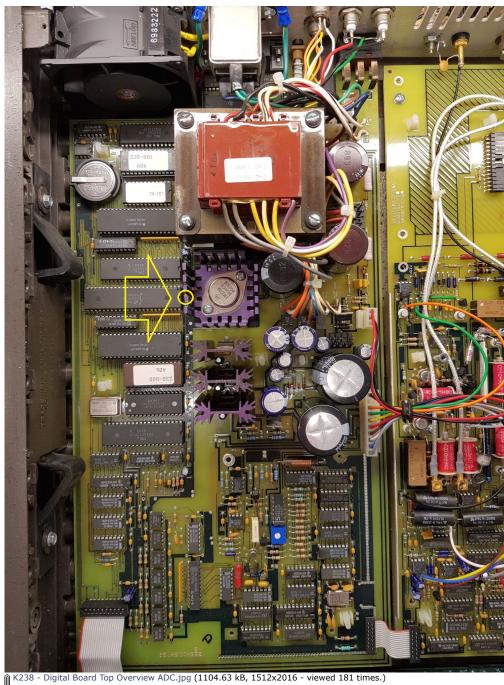
My guess is that it is a 0.01 uF capacity (20 %, 50 V, CERAMIC) as noted in the Keithley 236/7 service manual parts list. The broken capacitor on my board does not have signs of a label and I do not have a service manual for the Keithley 238 with schematics. @

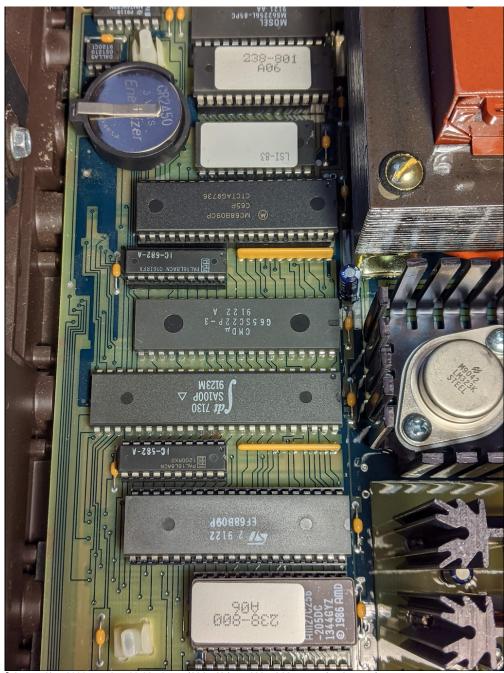
Screen Shot 2020-11-13 at 22.08.19.png (2961.68 kB, 1028x1366 - viewed 112 times.)

Thank you for your reply. I took pictures before and after the EPROM replacement. The 800 is located closer to the front which is an AM27C256-120DC (the notch points outwards to the case), whereas the 801 is located near the transformer which is an AM27C512-120DC (the notch points towards the transformer or inward). I copied the 238-800-A06 firmware to the new EPROM with success, so it shouldn't be about positioning. I tried to install the A10 firmware 3 times unsuccessfully. The same random display lights occurred each time. I also tried removing the battery and cycling the power supply to see if that would do anything. The EPROM programmer I used is a GQ-4X4 V4.
