Keithley Instruments
28775 Aurora Road
Cleveland, Ohio 44139
1-800-833-9200
tek.com/keithley

GENERAL INFORMATION

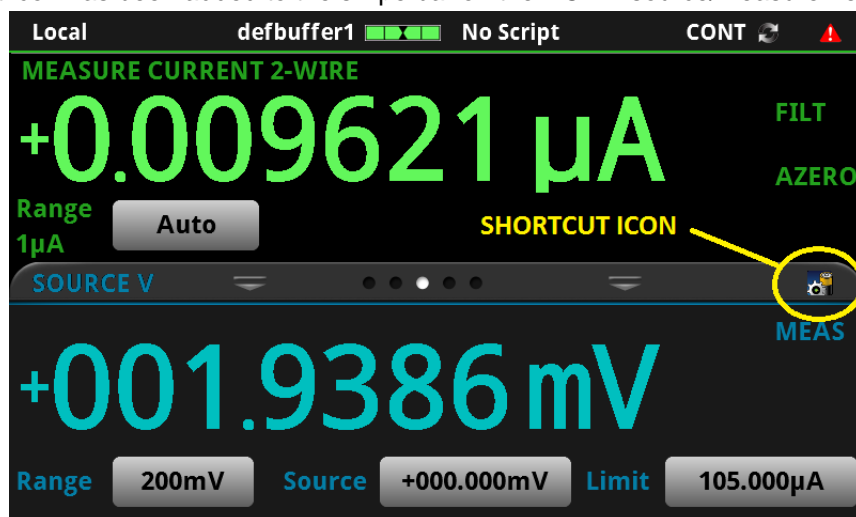
Add a direct shortcut from the HOME view measurement line to the measurement settings menu.

A shortcut icon has been added to the swipe bar on the HOME source/measurement tab.
