Keithley Instruments
28775 Aurora Road
Cleveland, Ohio 44139
1-800-833-9200
tek.com/keithley

Model 2450 Interactive SourceMeter® Instrument, 2450-NFP, 2450-RACK, 2450-NFP-RACK

VERSION 1.7.3 RELEASE

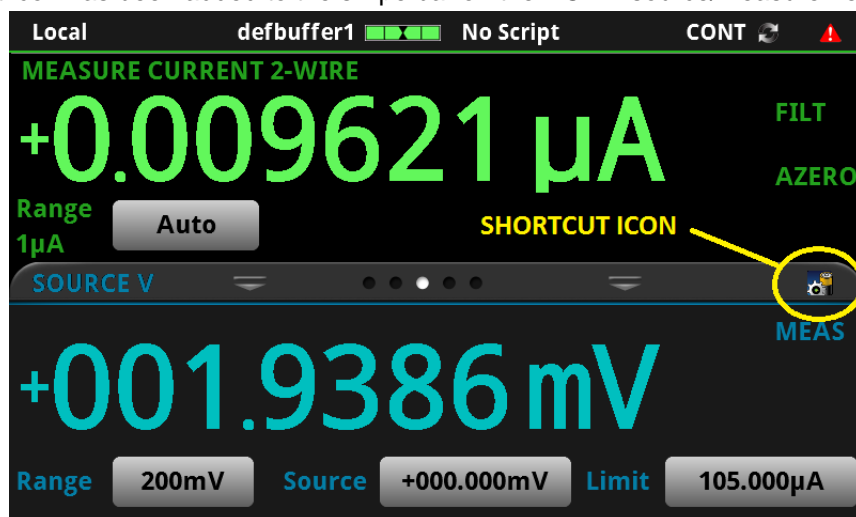
Add a direct shortcut from the HOME view measurement line to the measurement settings menu.

A shortcut icon has been added to the swipe bar on the HOME source/measurement tab.

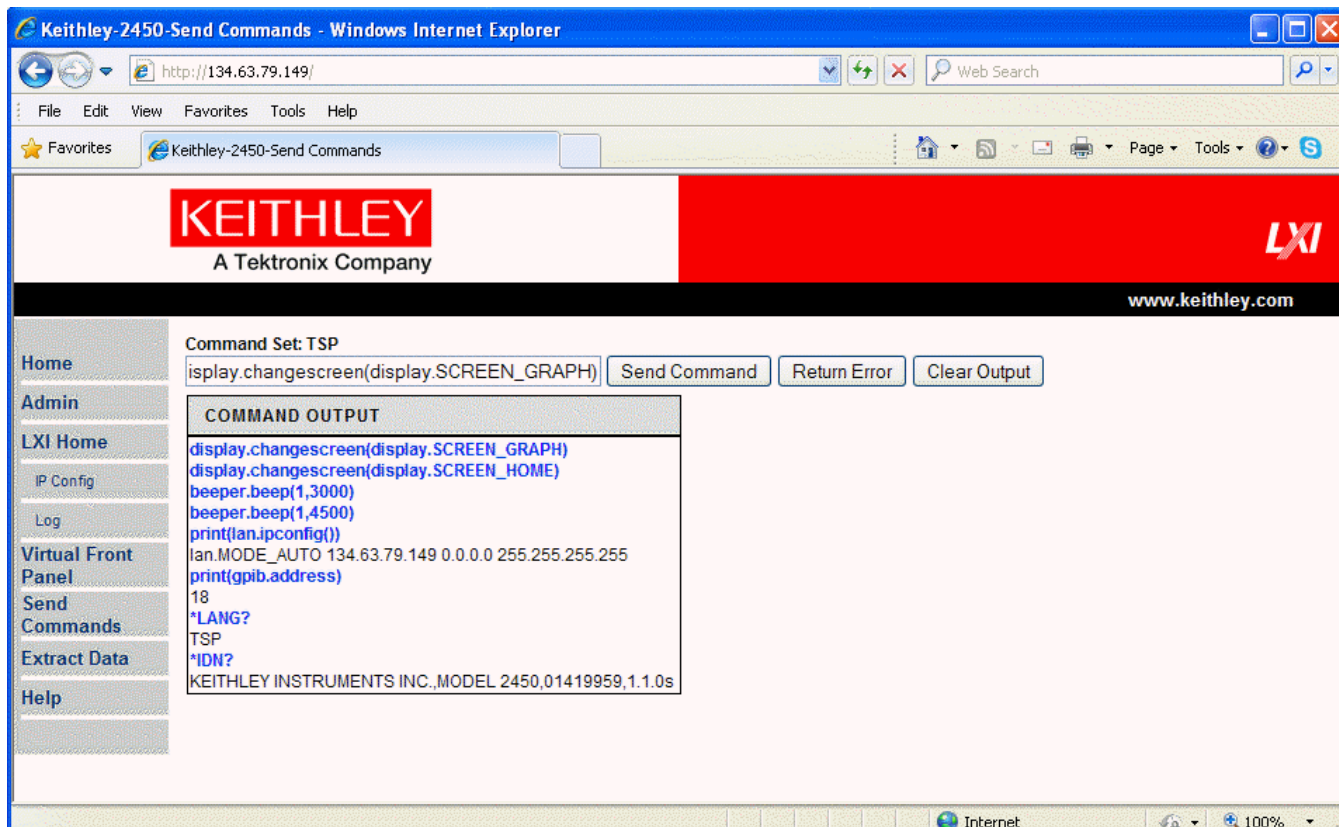
The 2450 built-in webpage has been enhanced to show a historical list of commands recently sent to the instrument. This new COMMAND OUTPUT window has been added to the Send Commands section of the webpage.

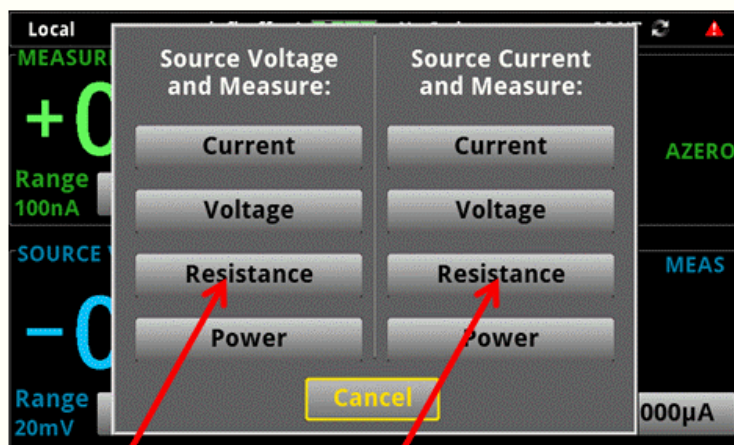
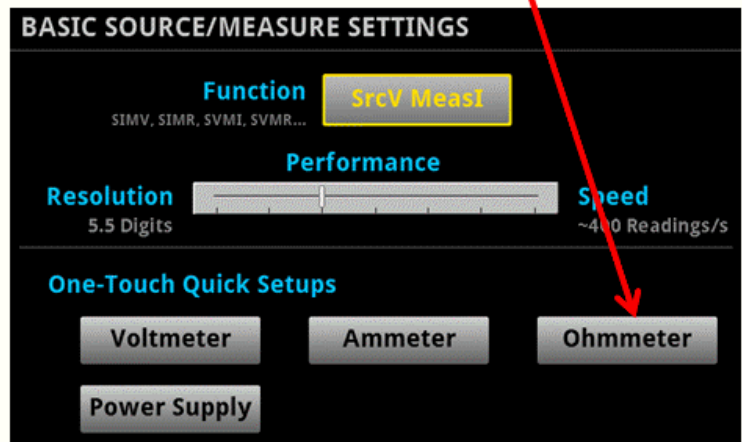
- g. New SCPI Command Usage:
 - i. "Manual Ohms" (see definition above)
 - SOURce:FUNC VOLTage
 - [SENSe[1]]:FUNC "CURREnt"
 - [SENSe[1]]:CURREnt:UNIT OHMOR
 - SOURce:FUNC CURREnt
 - [SENSe[1]]:FUNC "VOLTage"
 - [SENSe[1]]:VOLTage:UNIT OHM
 - ii. "Auto Ohms" (see definition above)
 - [SENSe[1]]:FUNC "RESistance"
- h. Front panel user interface setting of Manual vs. Auto Ohms measurements
<see the following figure for details>

SVMI (Ω) SIMV (Ω)

Both exhibit "Manual" Ohms behavior (works just like Power by setting units to Ohms and going to SVMI or SIMV)

Exhibits "Auto" Ohms behavior

SVMR

- `smu.source.func = smu.FUNC_DC_CURRENT`
 - `smu.voltage.func = smu.FUNC_DC_VOLTAGE`
 - `smu.measure.unit = smu.UNIT_OHM`
 - ii. “Auto Ohms” Measures resistance by sourcing current, measuring voltage, and calculating the resistance reading. In this case, the source current and source limit are automatically calculated and set.
 - `smu.measure.func = smu.FUNC_RESISTANCE`
