HP 83621A/31A/51A Synthesized Sweepers Troubleshooting Manual

HP Part No. 08360-90048
Printed in USA April 1993

Edition 4

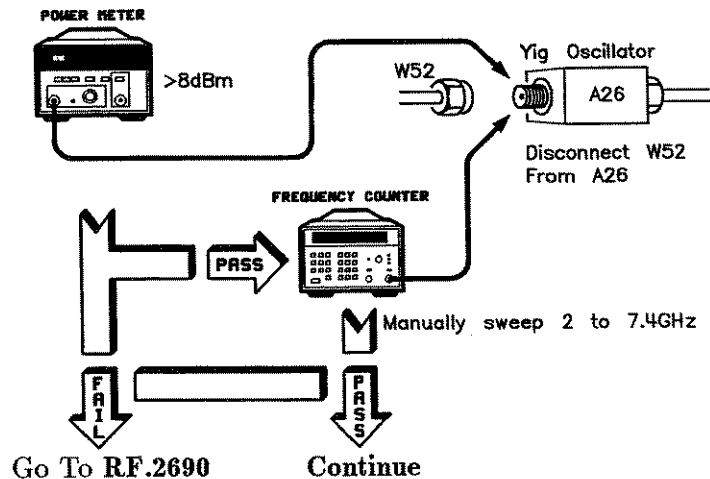
1. Press **2** **GHz**.
2. Using **▲**, increment the frequency.
3. The measured frequency equals the front panel indication ± 40 MHz (2 to 7 GHz).

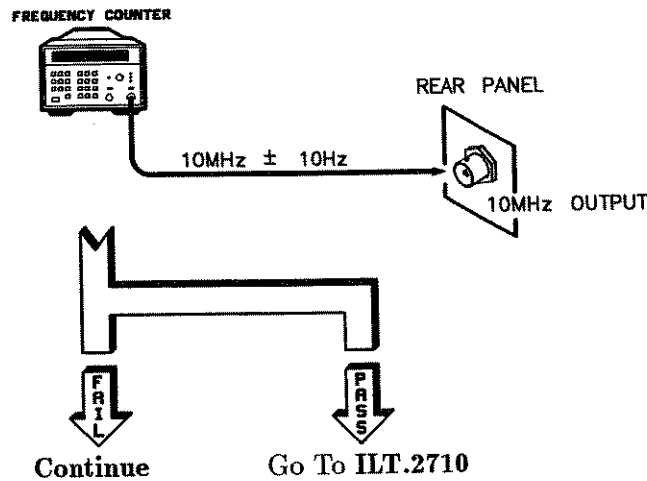
ILT.2700

ILT.2701 The 10 MHz standard is out of tolerance. Perform the “10 MHz Standard” adjustment (see the *Service manual*). If the 10 MHz output is still out of tolerance after performing the adjustment, go to A23.000 and replace the 10 MHz standard assembly.

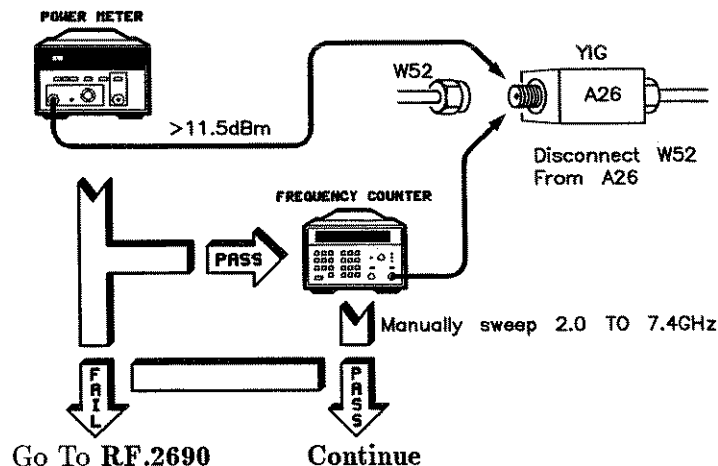
1. Press **2** **GHz**.
2. Using **▲**, increment the frequency.
3. The measured frequency equals the front panel indication ± 40 MHz (2.0 to 7.4 GHz).
