### Evaluates: MAX16137

The MAX16137 evaluation kit (EV kit) is designed to evaluate the MAX1613700/VY+, a 1% accuracy, window-detector supervisory reset IC with BIST (Built-In-Self-Test) capability and overvoltage fault output in an 8-pin TDFN package. Several test points are provided to facilitate device evaluation. The EV kit is fully assembled and tested over the automotive temperature range of -40°C and +125°C and is available with the MAX1613700/VY+ installed.

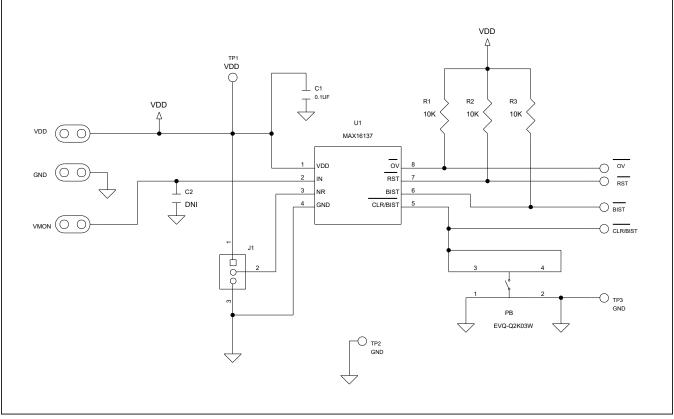
Figure 2. MAX16137EV Kit Schematic

The MAX16137 evaluation kit evaluates the MAX1613700/ VY+, a 1% accuracy, window-detector supervisory reset IC with BIST (Built-In-Self-Test) capability and overvoltage fault output.  $\overline{OV}$ ,  $\overline{RST}$ , and  $\overline{BIST}$  are open-drain outputs pulled up to VDD with external resistors. An optional capacitor (C2) provides additional filtering capability for the monitoring and a jumper (J1) facilitates configuration of the BIST during normal operation.

overvoltage threshold. The overvoltage fault is clear on the falling edge of the  $\overline{\text{CLR}/\text{BIST}}$  signal. Also, the push-button switch allows the MAX16137 to perform BIST operation during normal operation with the  $\overline{\text{CLR}}/\overline{\text{BIST}}$  voltage pulled low for more than 150µs(min). See Table 1 and the device data sheet for more details.

Jumper (J1) allows the MAX16137 to perform BIST either by pulling  $\overline{RST}$  low or without pulling  $\overline{RST}$  low during normal operation after power-up. See <u>Table 1</u> for the jumper setting.
